**1326 AND 1330 COUNTY ROUTE 7 FEASIBILITY STUDY
FOR
ANCRAM OPERA HOUSE THEATER, INC**

EXISTING CONDITIONS PHOTOGRAPHS AND DRAWINGS

EXISTING CONDITIONS PHOTO SURVEY
THE ANCRAM OPERA HOUSE AND 1326 COUNTY ROUTE 7

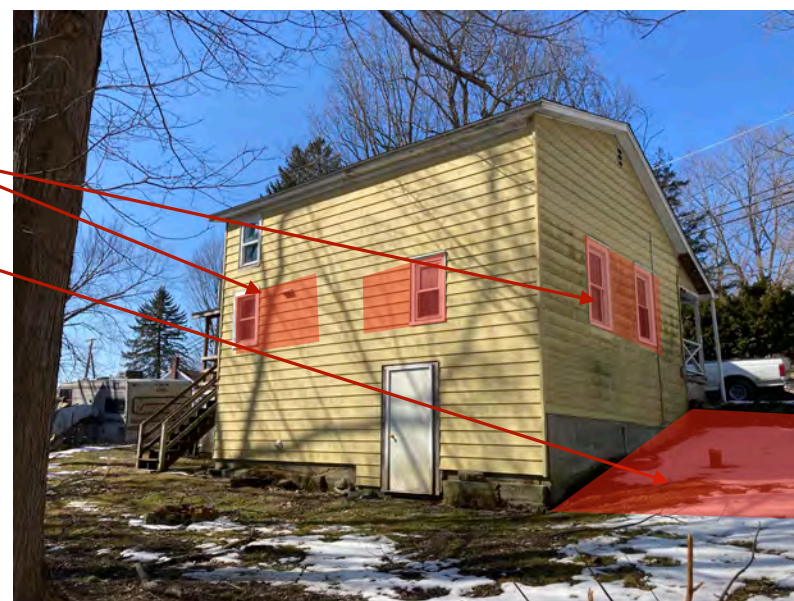
NEW OPENINGS

**AREA FOR NEW
CONNECTING PORCHES**

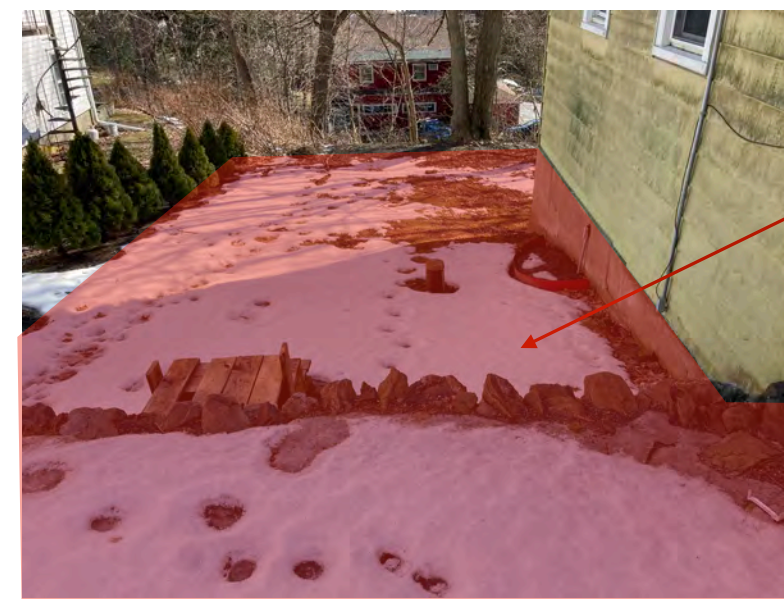
Area between the two buildings

NEW ADA RAMP

**AREA FOR NEW
CONNECTING PORCHES**
